Casting Drum Re-shell

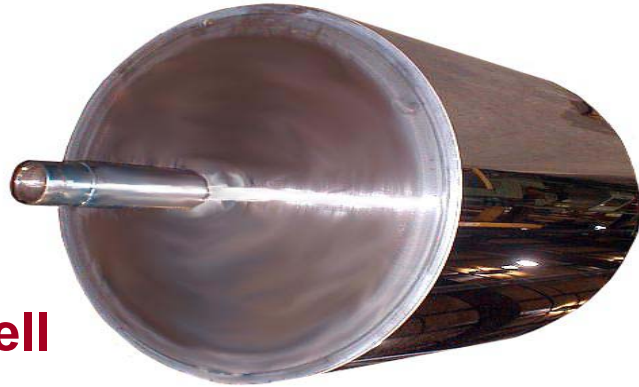
A customer in the plastic film industry was experiencing hot and cold spots on the surface of a cooled casting drum causing inferior quality product with variations in material thickness and clarity.

PFE Rolls diagnosed the casting drum as having poor fluid flow that was resulting in localized, poor heat transfer. The fluid flow was being restricted by corrosion of the internal passages and a build-up of sludge from untreated cooling water.

The outer shell was removed from the roll while saving the shafts and internal structure of the roll. All exposed internal flow passages were thoroughly cleaned and built up to the proper diameter. A new outer shell of rolled and welded steel was bored inside to achieve a uniform wall thickness. The new outer shell was then heat-shrunk onto the internal assembly and welded in place.

To prevent future corrosion of the internal flow passages, the completed, welded assembly was acid flushed and electroless nickel plated.

The outer surface of the casting drum was chrome plated, ground and super finished to a 0 – ½ micro-inch Ra surface finish with T.I.R. and straightness within .0005".
